ASBESTOS-CONTAINING MATERIALS AND LEAD-CONTAINING MATERIALS SURVEY REPORT

COMMERCIAL PROPERTY
777 WEST ORANGETHORPE AVENUE
PLACENTIA, CALIFORNIA 90065

PROJECT No. 092878-AS, XRF

REPORT DATE: JUNE 18, 2021

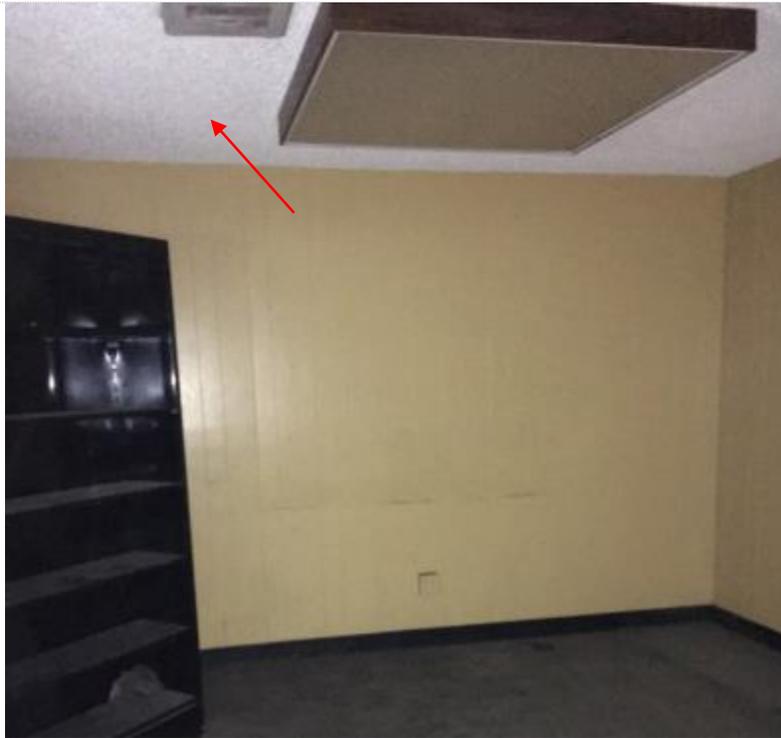
Photo #3: Photo of positive sample group 0603-02 – White Acoustic

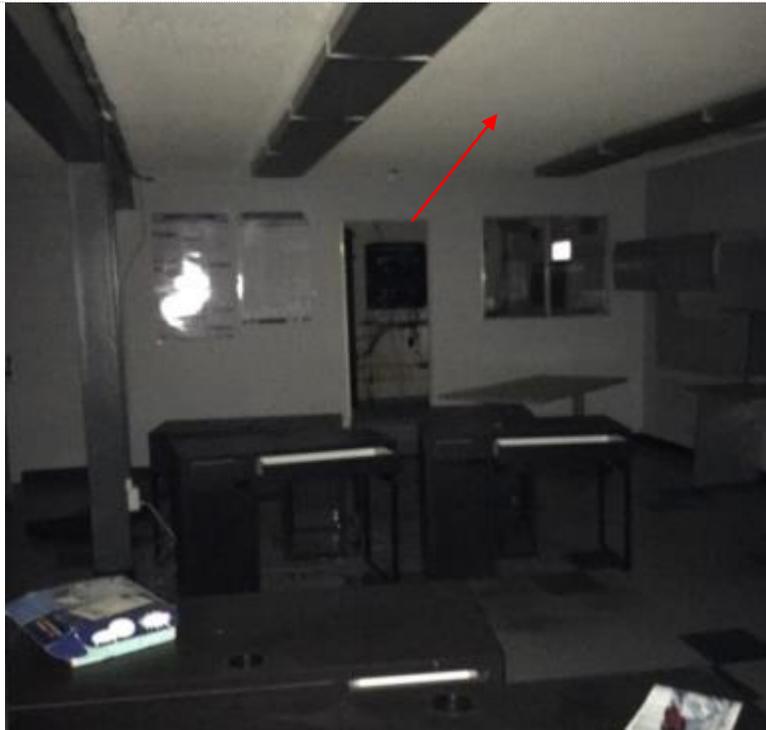
Photo #4: Photo of positive sample group 0603-02 – White Acoustic

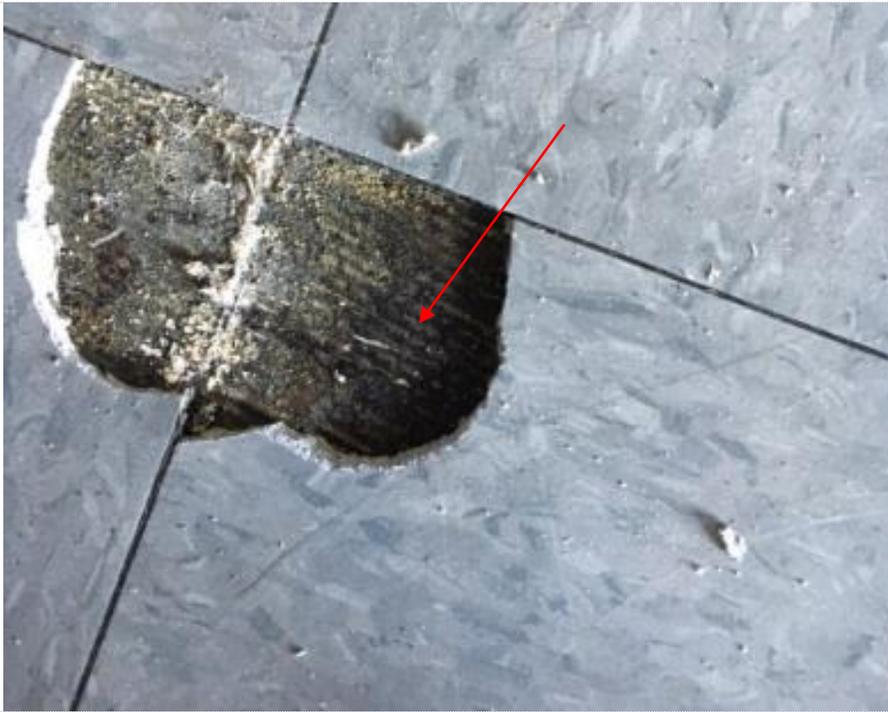
Photo #5: Photo of sample group 0603-08 (12x12 gray floor tile) and positive sample group 0603-09 (black mastic),

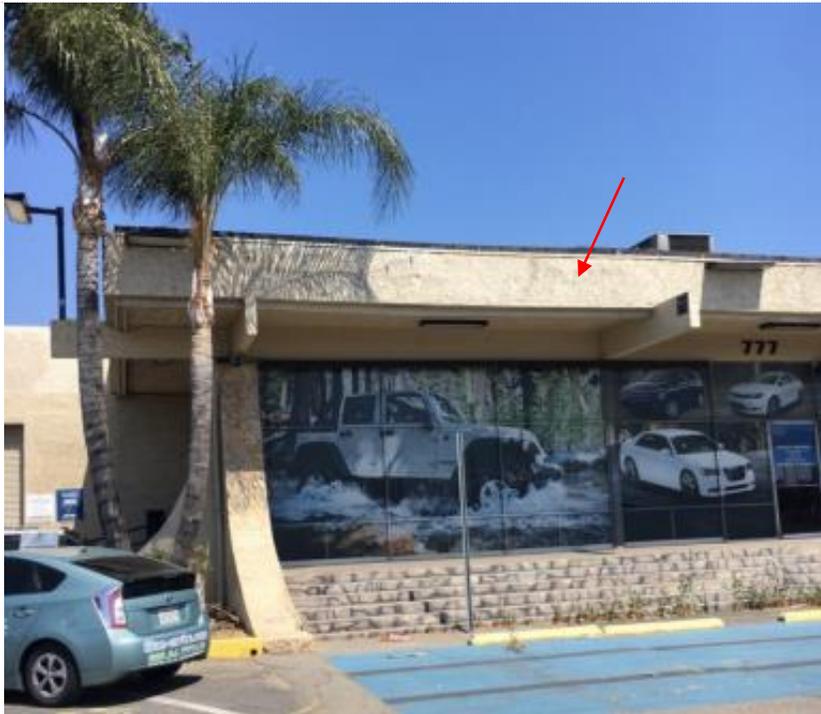
Photo #6: Photo of positive sample group 0603-18 (gray stucco)

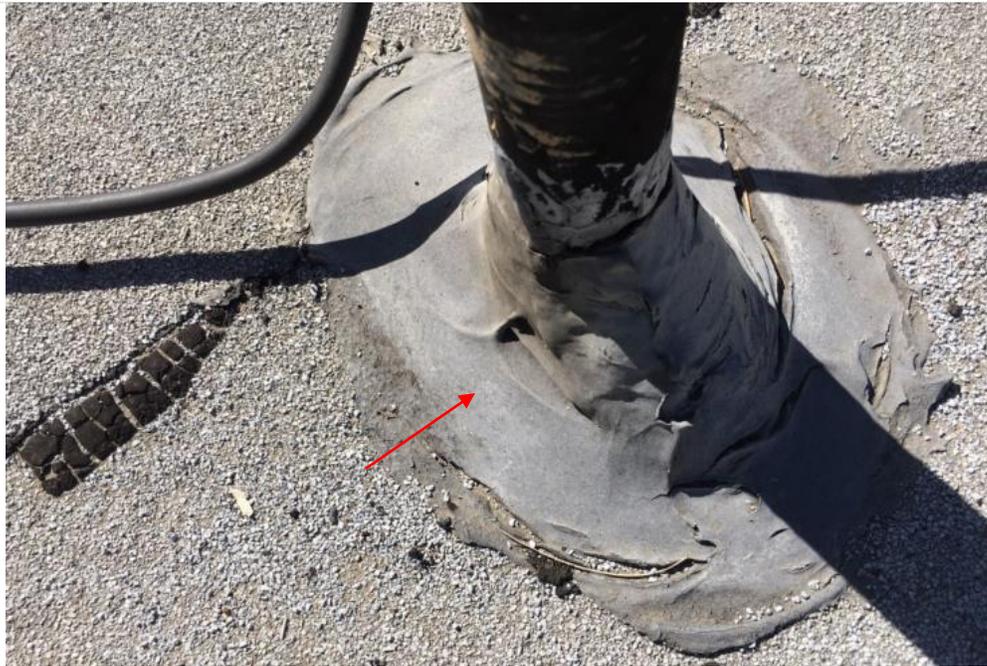
Photo #7: Photo of positive sample group 0610-04 – Gray Roof Penetration Mastic

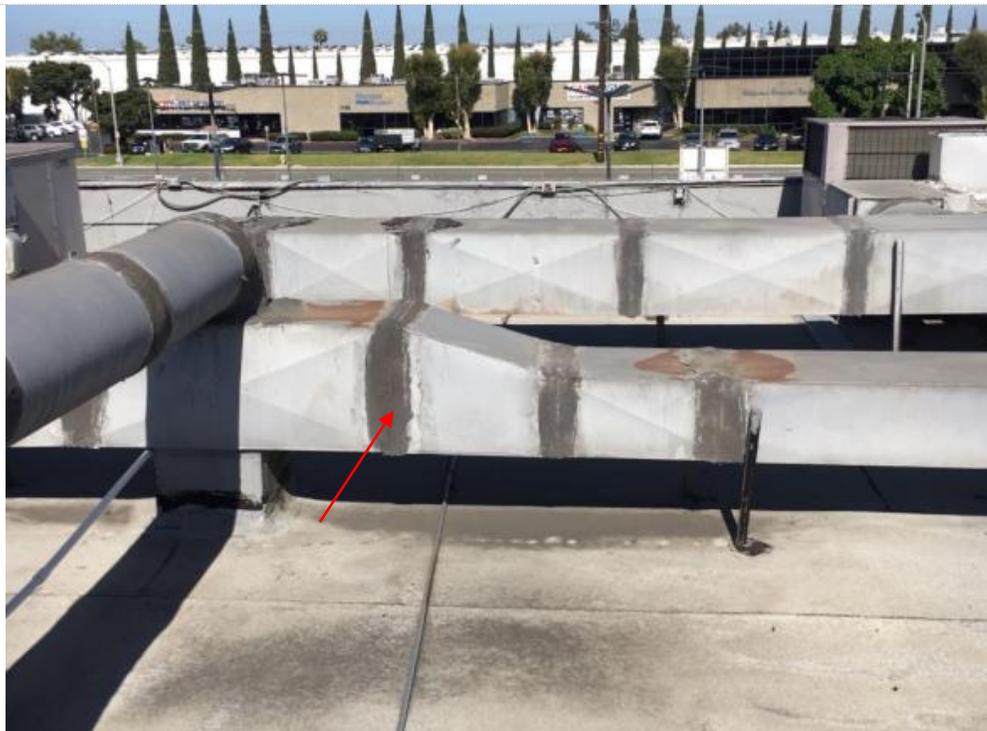
Photo #8: Photo of positive sample group 0610-05 – Gray HVAC Duct Mastic
