ARBORIST REPORT
FOR THE
SANTA ANGELINA SENIOR APARTMENT HOMES
CITY OF PLACENTIA, ORANGE COUNTY, CALIFORNIA

August 28, 2020

ATTACHMENT 1
ARBORIST TREE INVENTORY SHEET

ATTACHMENT 2
TREE INVENTORY PHOTO APPENDIX

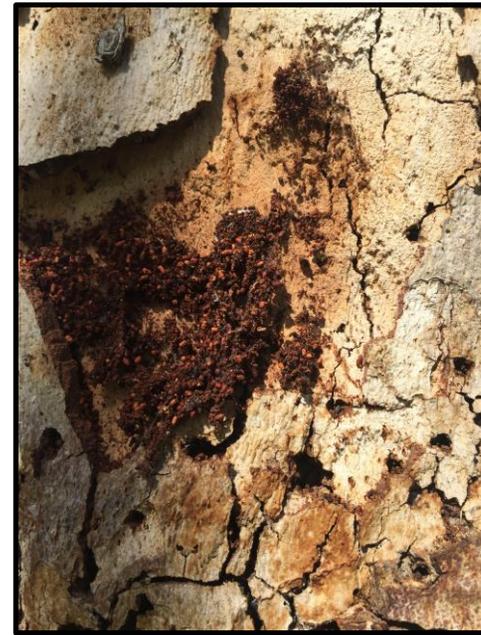
PHOTO 2: Frass associated with 3 mm holes on tree trunk of western sycamore; Tree SRT1.

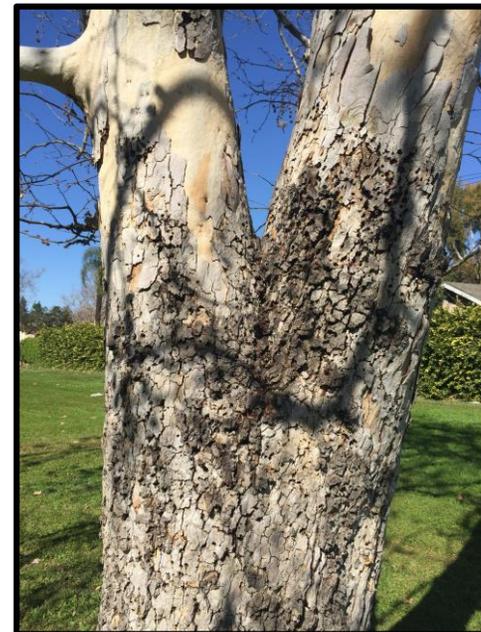
PHOTO 4: Co-dominant trunk with included bark on western sycamore tree; Tree SRT2.

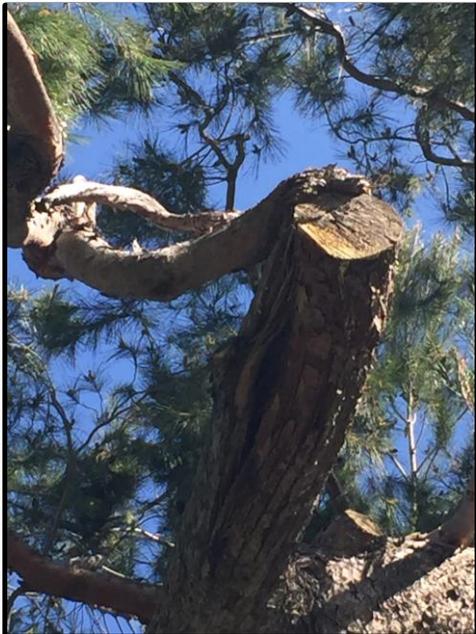
PHOTO 11: Pruning damage and splitting bark on Scotch pine tree; Tree SRT8.

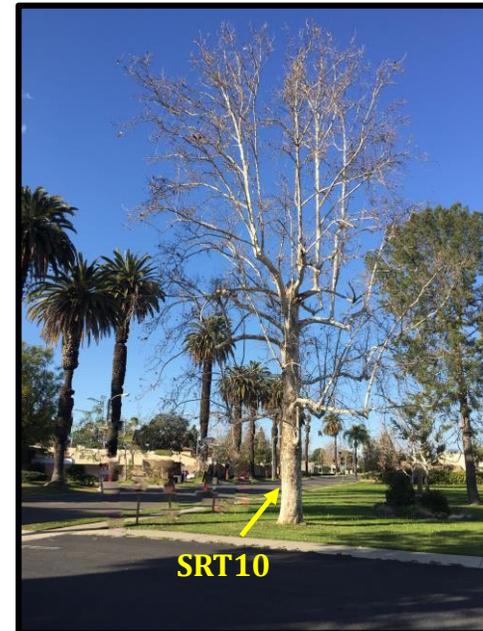
PHOTO 12: View facing northwest at western sycamore tree; Tree has been topped and lacks dominant trunk in top half. Tree SRT10.

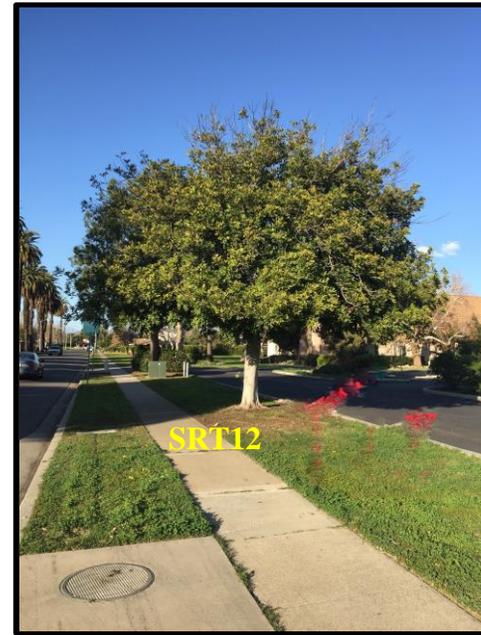
PHOTO 14: Facing north at carrotwood tree; Tree SRT12.

SRT12 CUAN	carrotwood	<i>Cupaniopsis anacardioides</i>	33.88537908	-117.861945	1	14.9	24.8	38.4	3	Dieback of top 5% of canopy; included bark cuts on trunk; flowering, healthy leaves
SRT13 PISP	pine tree	<i>Pinus spp.</i>	33.88522392	-117.8619448	3	16.8	13.4	31.6	3	5% canopy dieback; small stature; heavily pruned
SRT14 CUAN	carrotwood	<i>Cupaniopsis anacardioides</i>	33.88515954	-117.8618321	1	11.7	17.4	28.6	2	20% canopy dieback; crown top dieback; co-dominant trunks; inclusion; burls; 50% leaves chlorotic; rust spots; flowering; ants
SRT15 CUAN	carrotwood	<i>Cupaniopsis anacardioides</i>	33.88512715	-117.8617406	2	22.2	23.1	32.2	4	Burls; flowering; healthy leaves; some graffiti; ants
SRT16 CUAN	carrotwood	<i>Cupaniopsis anacardioides</i>	33.885111°	-117.861695°	1	11.1	24.6	33.6	4	10% diseased leaves; curled; flowering; healthy canopy; ants; stress at base of trunk; graffiti; burls on roots
SRT17 CUAN	carrotwood	<i>Cupaniopsis anacardioides</i>	33.885079°	-117.861601°	1	14.7	26.5	40.5	4	healthy canopy; flowering; 5% curled leaves

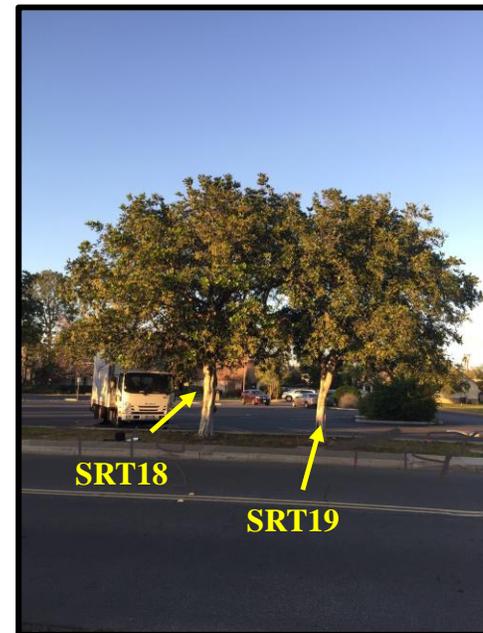
PHOTO 20: View facing north at two carrotwood trees. Trees SRT18 (left) and SRT19 (right).

SRT18 CUAN	carrotwood	<i>Cupaniopsis anacardioides</i>	33.885043°	-117.861492°	1	14.9	27.7	41.8	5	flowering; healthy leaves; ants; good taper; scratches on trunk; root damage

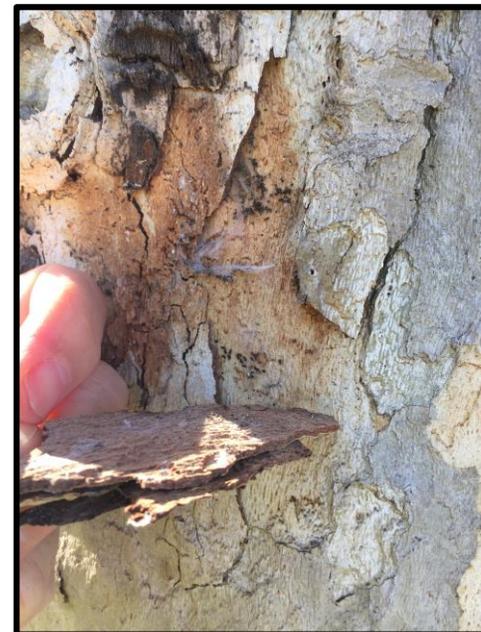
PHOTO 24: View under bark of frass associated with 3-6 mm holes on trunk of western sycamore tree. Tree SRT22.

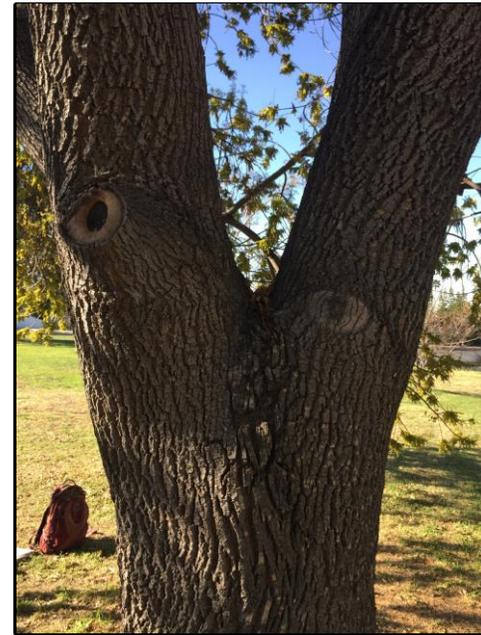
PHOTO 26: Co-dominant trunks with included bark; Tree SPT23.

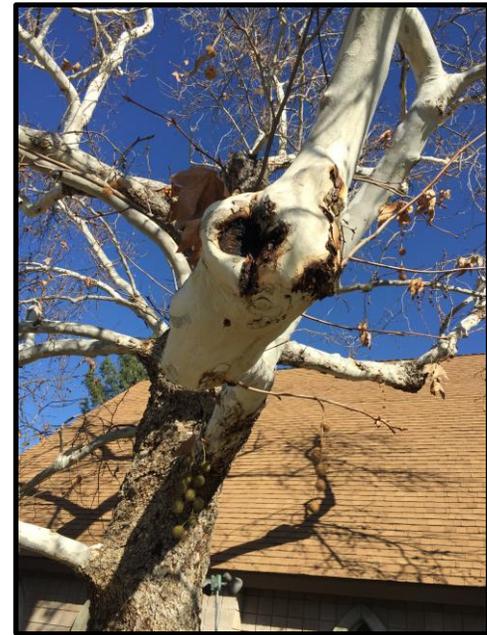
PHOTO 30: pruning scars on western sycamore tree; Tree SRT26.

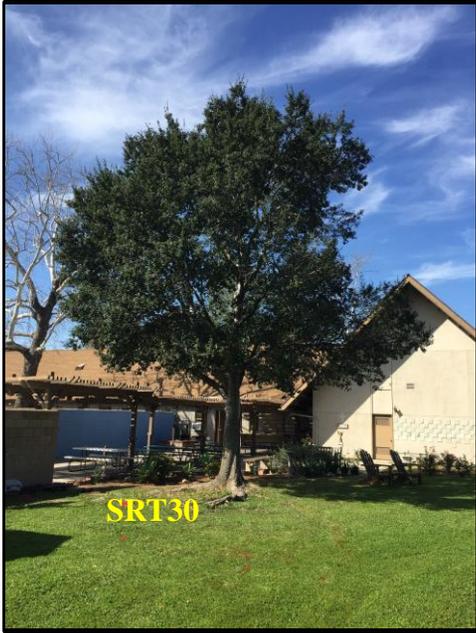
PHOTO 33: View facing southwest at coast live oak tree; Tree SRT30.

SPT30 QUAG	coast live oak	<i>Quercus agrifolia</i>	33.88601363	-117.8609855	1	17.8	34.8	50.2	4	included bark; poor taper; lean; 10% diseased leaves; chlorotic; some root girdling
NSRT1 PLRA	western sycamore	<i>Platanus racemosa</i>	33.88603728	-117.8607721	N/A	N/A	N/A	40.9	N/A	N/A
NSRT2 PISP	cherry tree	<i>Prunus sp.</i>	33.88610842	-117.8608987	N/A	N/A	N/A	36.7	N/A	N/A
NSRT3 CUAN	carrotwood	<i>Cupaniopsis anacardioides</i>	33.8862841	-117.860973	N/A	N/A	N/A	38.8	N/A	N/A
NSRT4 ALJU	silk tree	<i>Albizia julibrissin</i>	33.885400°	-117.861001°	N/A	N/A	N/A	8.0	N/A	N/A
NSRT5 MENE	pink melaleuca	<i>Melaleuca nesophila</i>	33.885603°	-117.861273°	N/A	N/A	N/A	6.3	N/A	N/A
NSRT6 MEAZ	bead tree	<i>Melia azederach</i>	33.885604°	-117.861334°	N/A	N/A	N/A	13.0	N/A	N/A
NSRT7 THOC	American arborvitae	<i>Thuja occidentalis</i>	33.885640°	-117.861415°	N/A	N/A	N/A	16.7	N/A	N/A

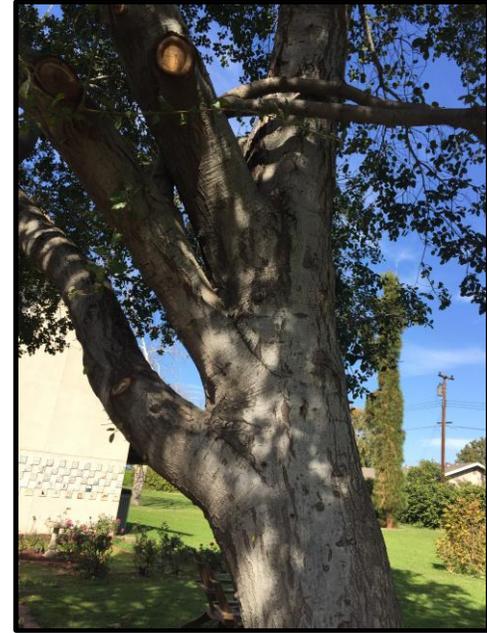
PHOTO 34: Pruning scars on coast live oak tree; Tree SRT30.
