**APPENDIX B**  
**LABORATORY TEST RESULTS**

# MODIFIED PROCTOR COMPACTION TEST

**Former Boys & Girls Club of Placentia**  
132 East Crowther Avenue  
County of Orange • Placentia, California

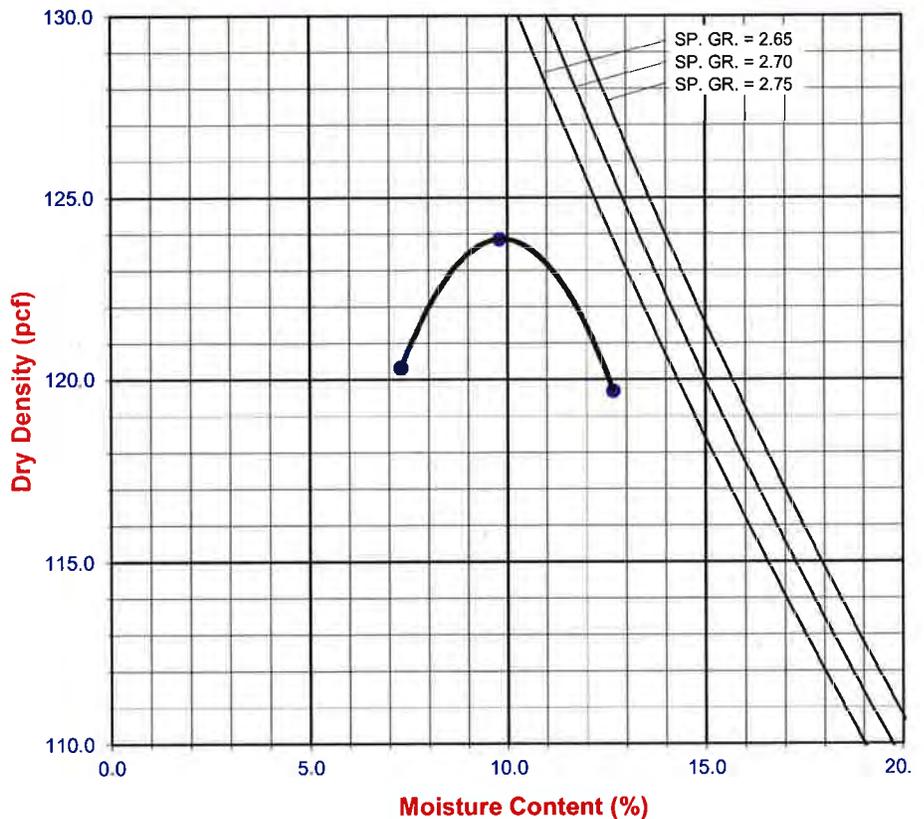
**Maximum Dry Density (pcf)** 124.0 **Optimum Moisture Content (%)** 10.0

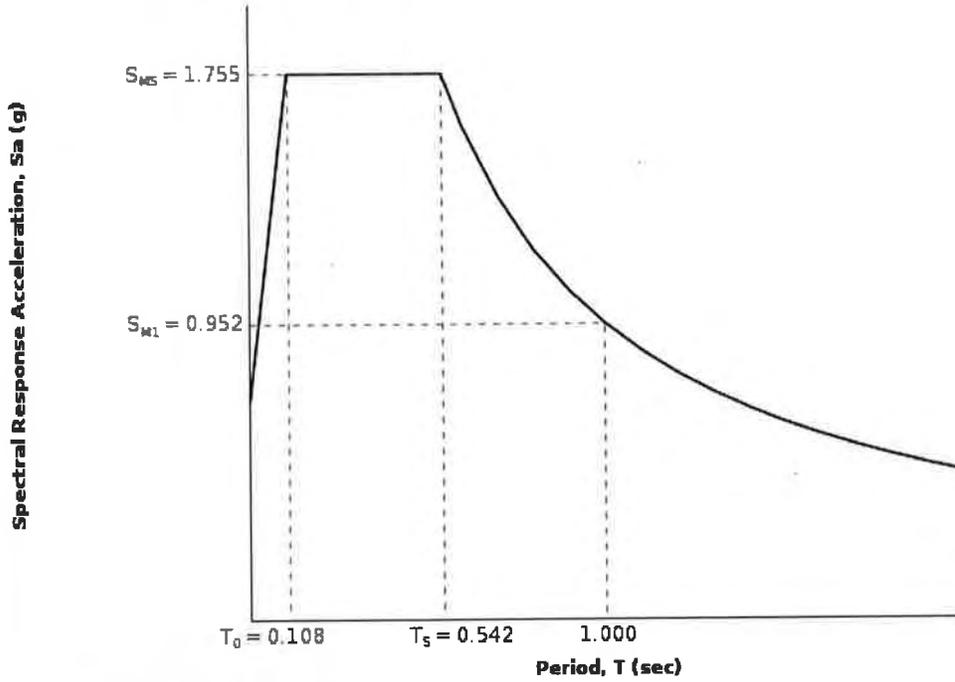
### Section 11.4.6 — Risk-Targeted Maximum Considered Earthquake (MCE<sub>R</sub>) Response Spectrum

The MCE<sub>R</sub> Response Spectrum is determined by multiplying the design response spectrum above by 1.5.

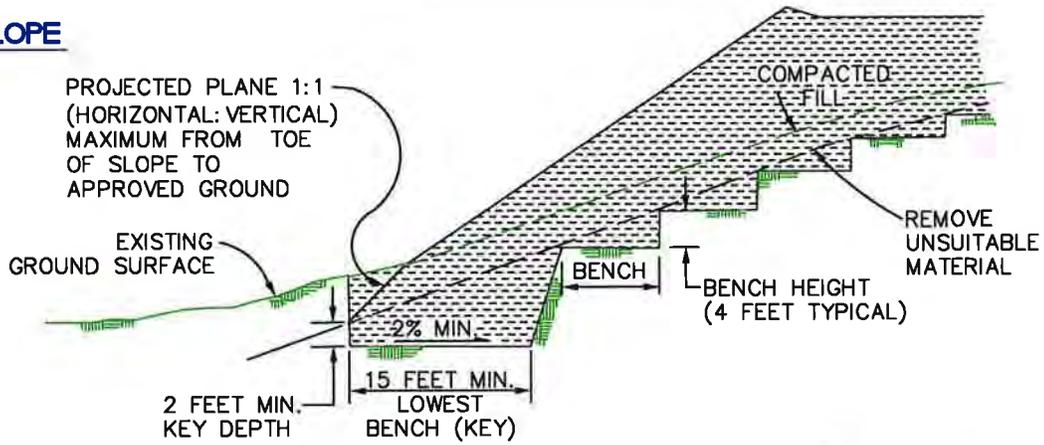
**FILL SLOPE**

Where fills are to be placed on ground with slopes steeper than 5:1 (horizontal to vertical units), the ground shall be stepped or benched. Please see the Standard Details for a graphic illustration. The lowest bench or key shall be a minimum of 15 feet wide and at least 2 feet deep, into competent material as evaluated by the Geotechnical Consultant. Other benches shall be excavated a minimum height of 4 feet into competent material or as otherwise recommended by the Geotechnical

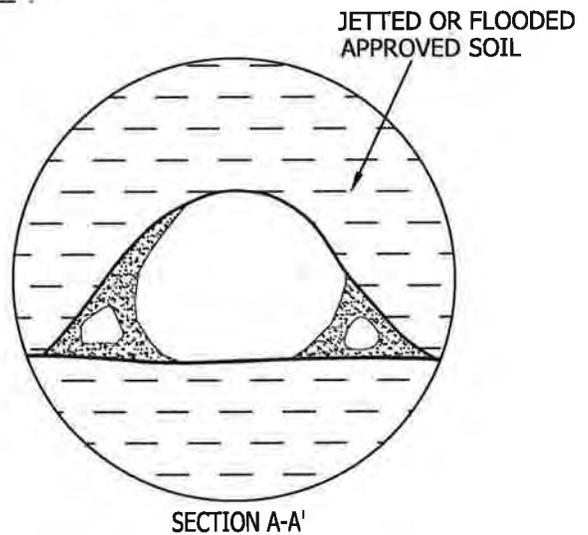
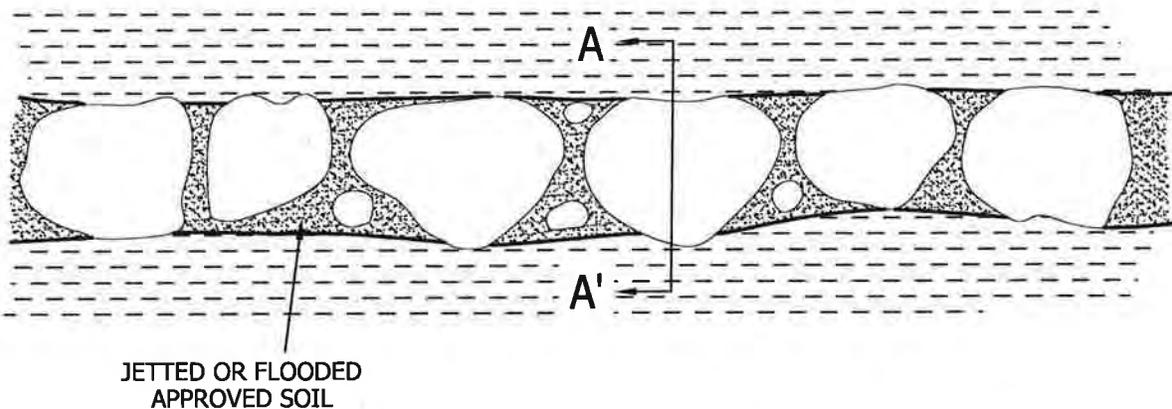
OVERSIZE ROCK DISPOSAL

- Oversize rock is larger than 8 inches in largest dimension.
- Backfill with approved soil jetted or flooded in place to fill all the voids.
- Do not bury rock within 10 feet of finish grade.
- Windrow of buried rock shall be parallel to the finished slope face.

PROFILE ALONG WINDROW

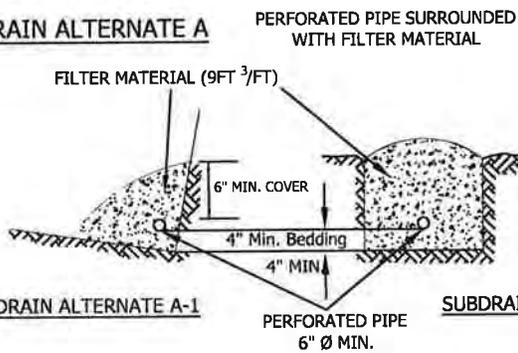
**SUBDRAIN ALTERNATE A**

**FILTER MATERIAL**  
 FILTER MATERIAL SHALL BE CLASS 2 PERMEABLE MATERIAL PER STATE OF CALIFORNIA STANDARD SPECIFICATION, OR APPROVED ALTERNATE.  
 CLASS 2 GRADING AS FOLLOWS:

Sieve Size	Percent Passing
1"	100
3/4"	90-100
3/8"	40-100
No. 4	25-40
No. 8	18-33
No. 30	5-15
No. 50	0-7
No. 200	0-3

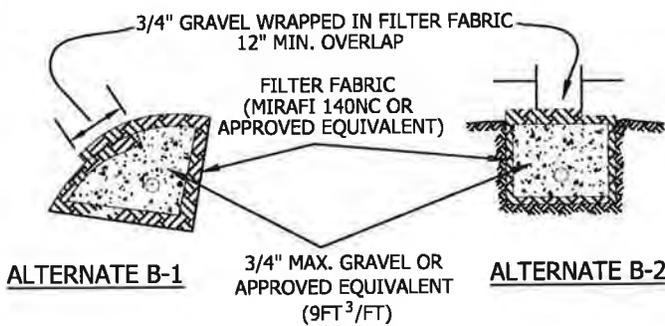
**SUBDRAIN ALTERNATE B**

○ PERFORATED PIPE IS OPTIONAL PER GOVERNING AGENCY'S REQUIREMENTS

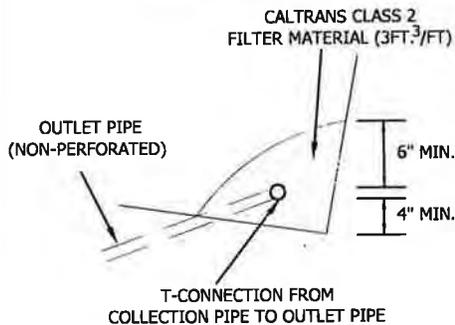
**SUBDRAIN ALTERNATE A**

POSITIVE SEAL SHOULD BE PROVIDED  
 AT THE JOINT

- **SUBDRAIN INSTALLATION** - Subdrain collector pipe shall be installed with perforations down or, unless otherwise designated by the geotechnical consultant. Outlet pipes shall be non-perforated pipe. The subdrain pipe shall have at least 8 perforations uniformly spaced per foot. Perforation shall be 1/4" to 1/2" if drilled holes are used. All subdrain pipes shall have a gradient at least 2% towards the outlet.
- **SUBDRAIN PIPE** - Subdrain pipe shall be ASTM D2751, ASTM D1527 (Schedule 40) or SDR 23.5 ABS pipe or ASTM D3034 (Schedule 40) or SDR 23.5 PVC pipe.
- All outlet pipe shall be placed in a trench and, after fill is placed above it, rodged to verify integrity.

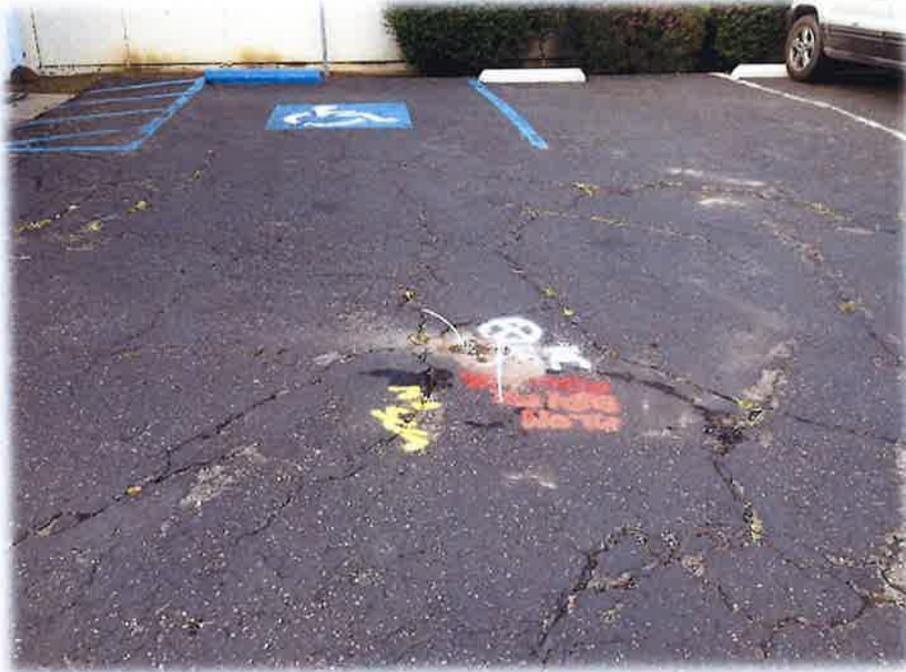
1. View of soil gas sample location EE-1. "Wells" were required due to elevated clay content. Wells installed at 5' and 15' bgs.

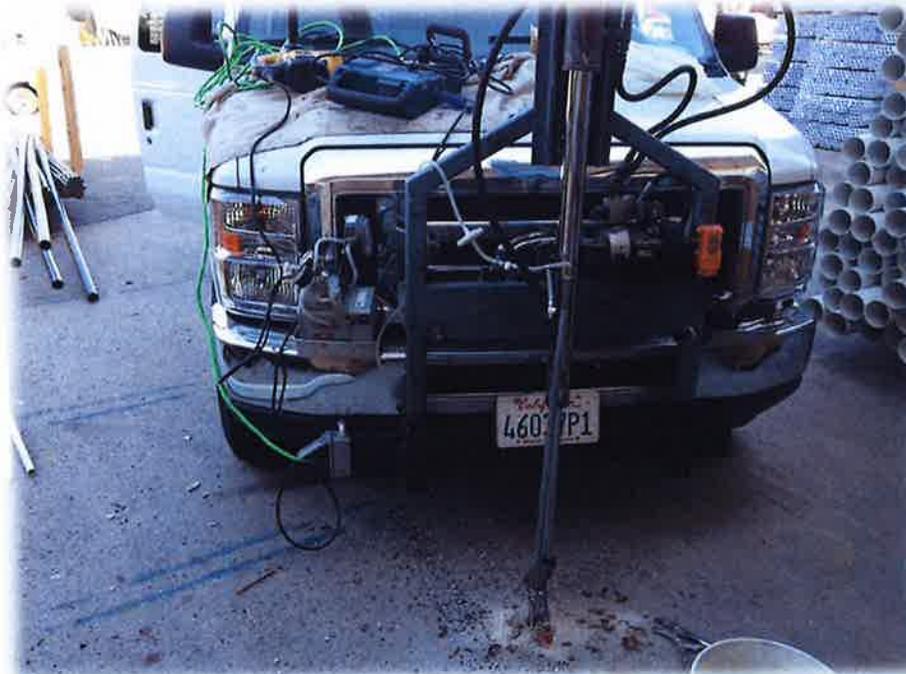
2. View of location EE-6 which is in area of former USTs that exhibited solvent detection. Flow was good, therefore, probe sampling occurred.

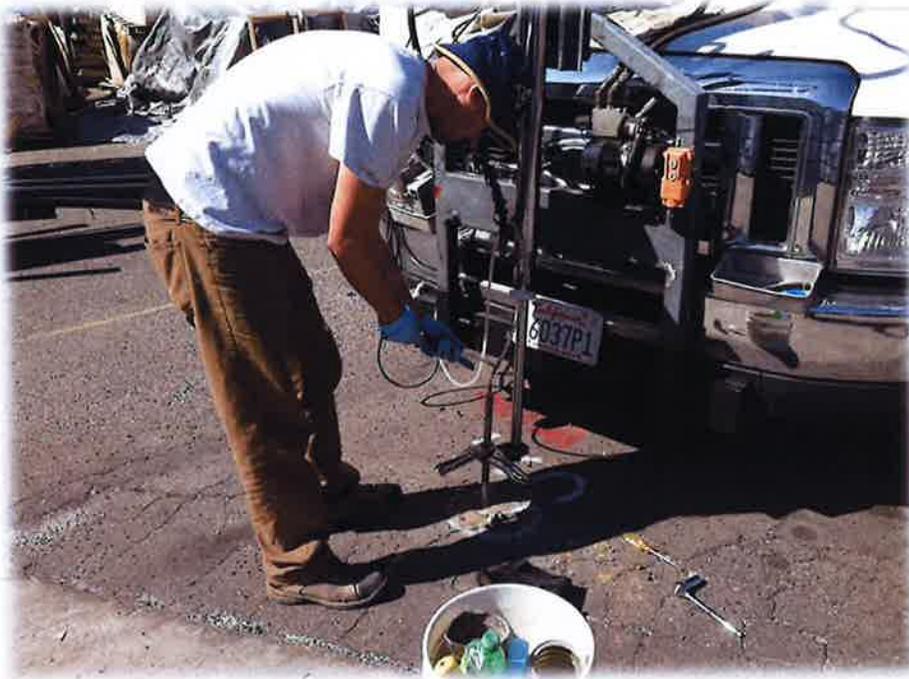
3. View of soil gas sample collection using glass barrel syringe.

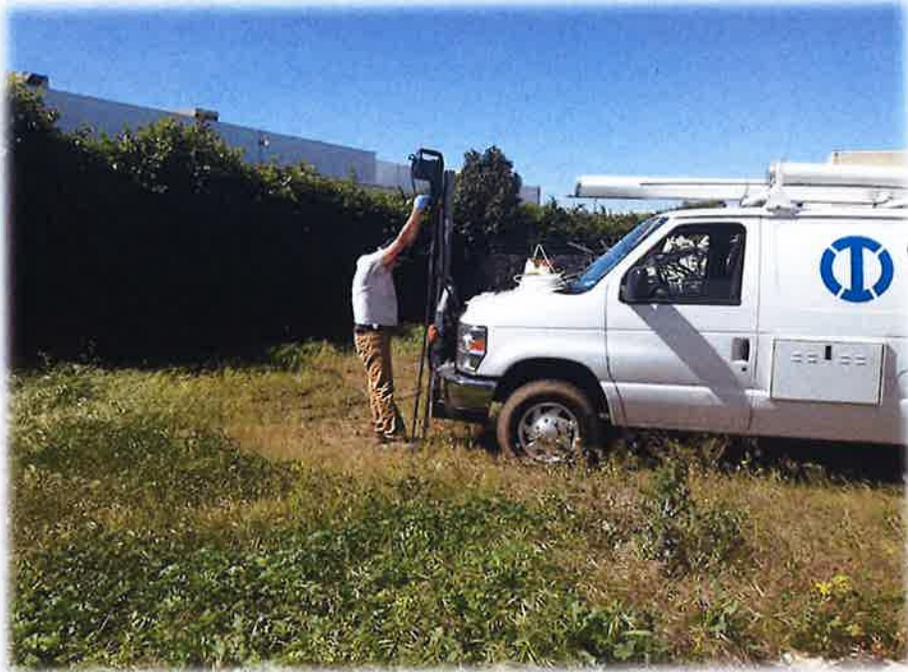
3. Using roto-hammer to advance 15' probe at location BGC-5 at south portion of lot.
